WASHINGTON STATE DEPARTMENT OF
Natural Resources

North Puget Sound Aquatic Lands Restoration Program

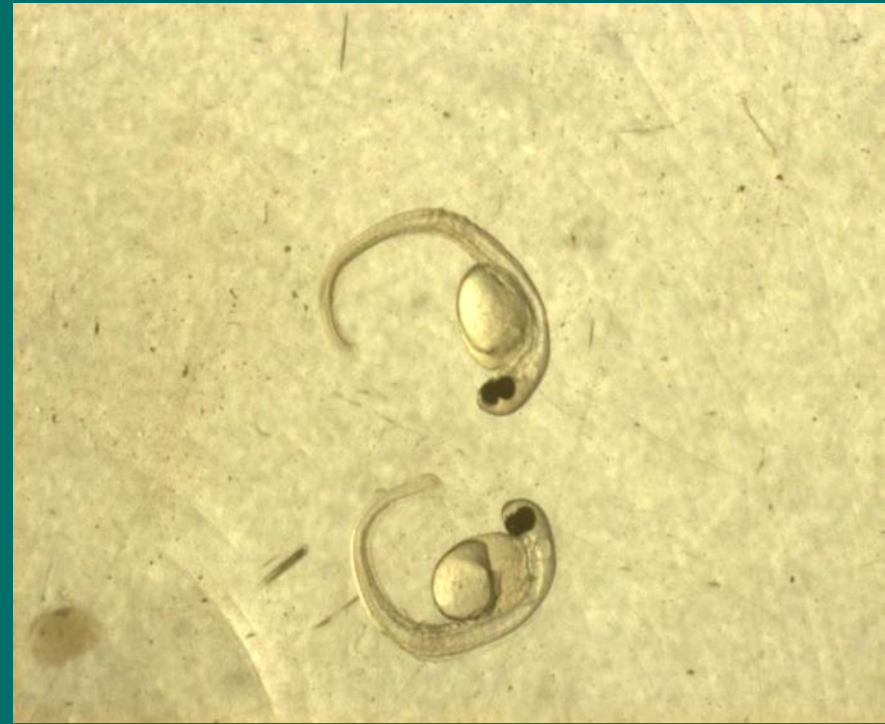
Herring embryos in 0.75% creosote solution (From Shannon Point study)

- Decreased heart rate in developing herring embryos at 3ppb
- Up to 92% herring egg mortality rate if spawn on creosote piling
- Liver lesions in English Sole
- Accumulations in tissues of shellfish

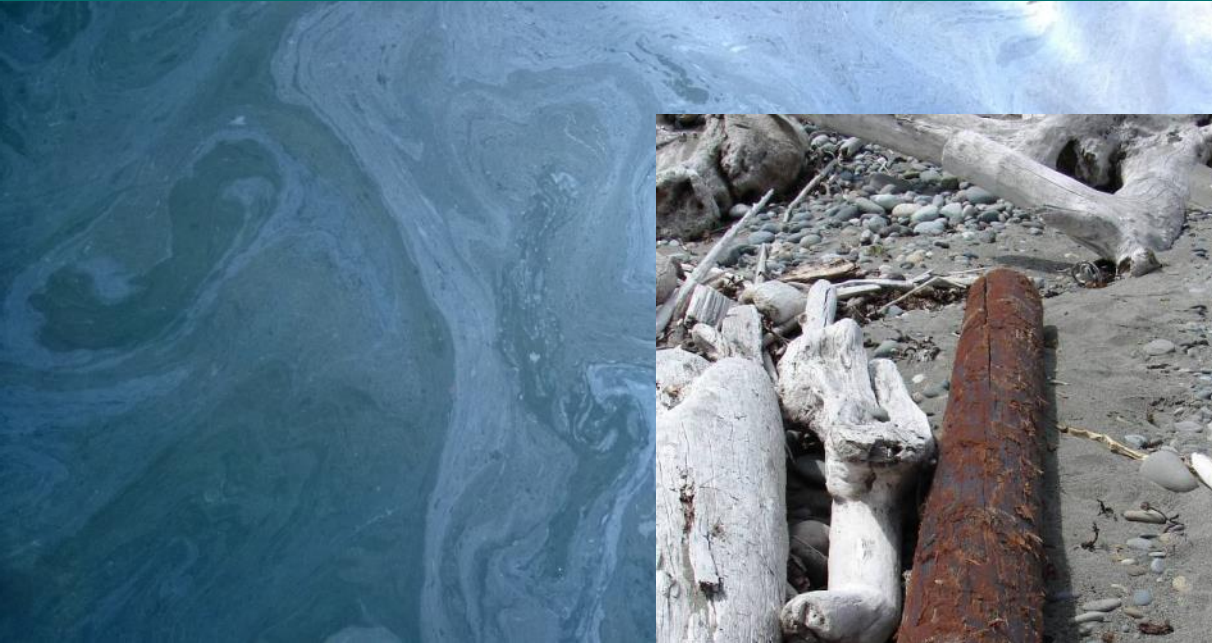
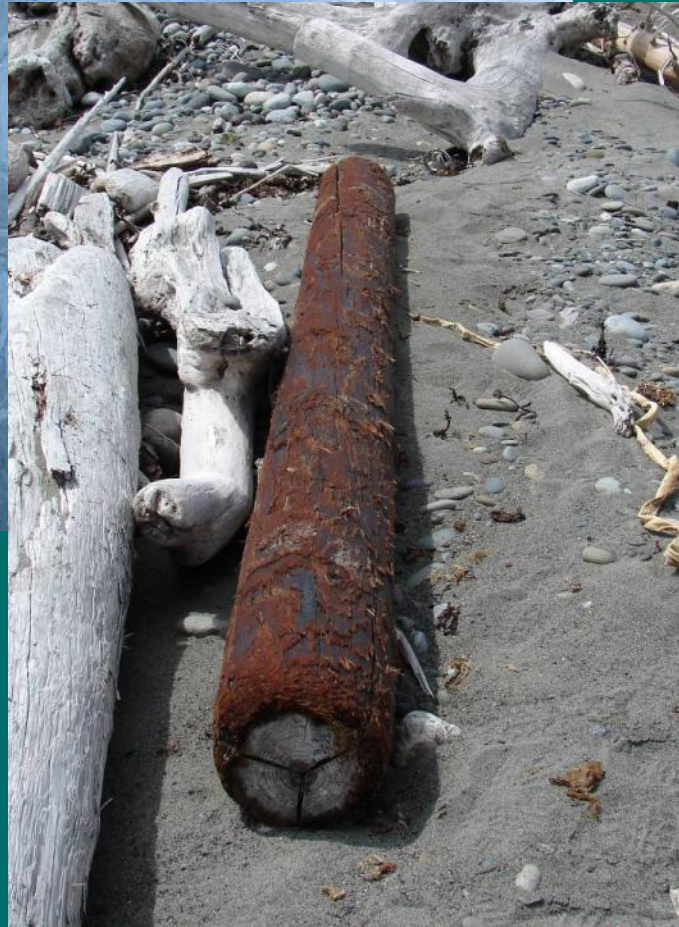
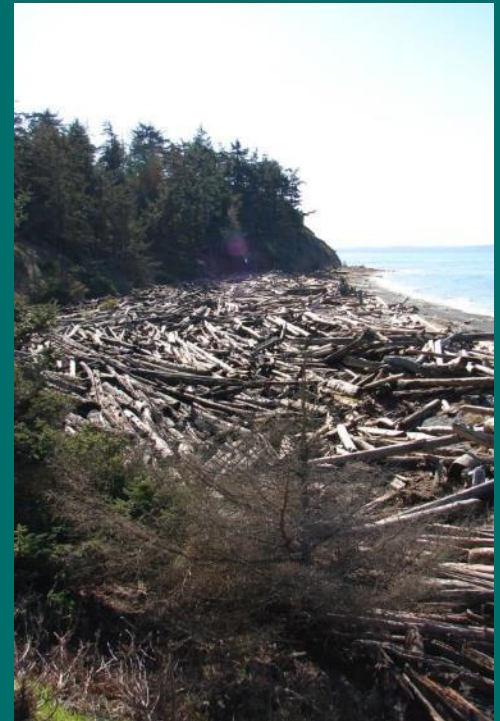
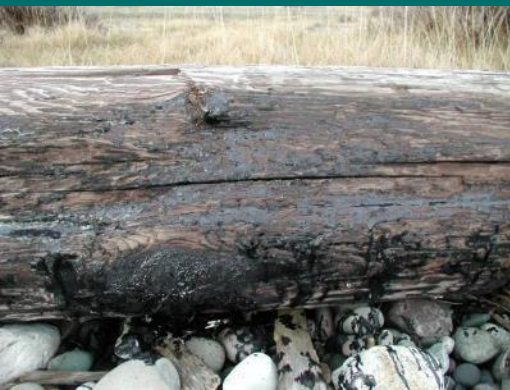
Identifying Creosote

- Black/Tar-like goo
- Rotting from the inside-out
- Blackened outer ring on the end
- Railroad ties
- Injection Marks
- Goo in the knots

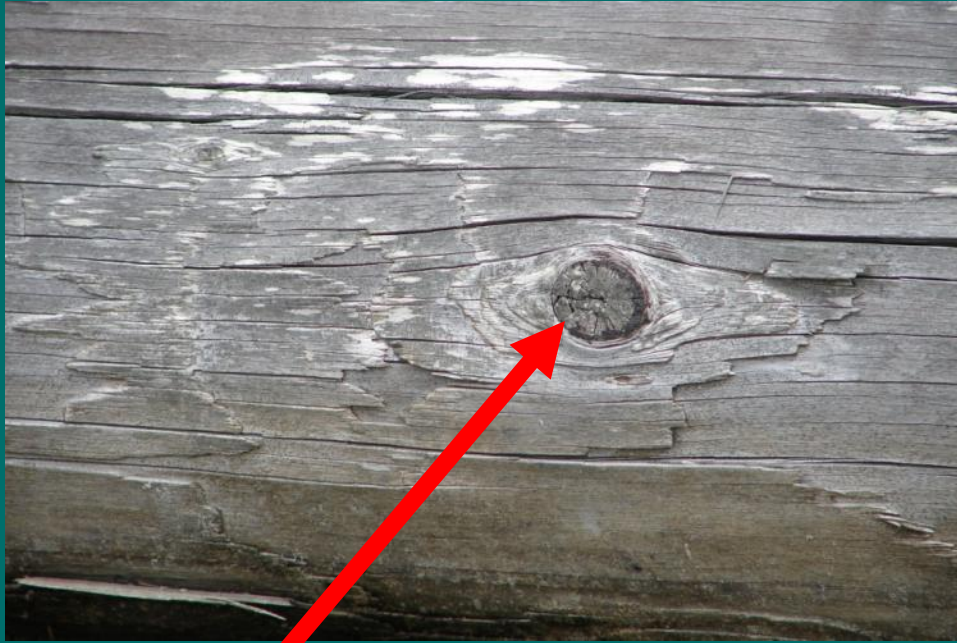
Look closely at the knots-this one has some oozing.

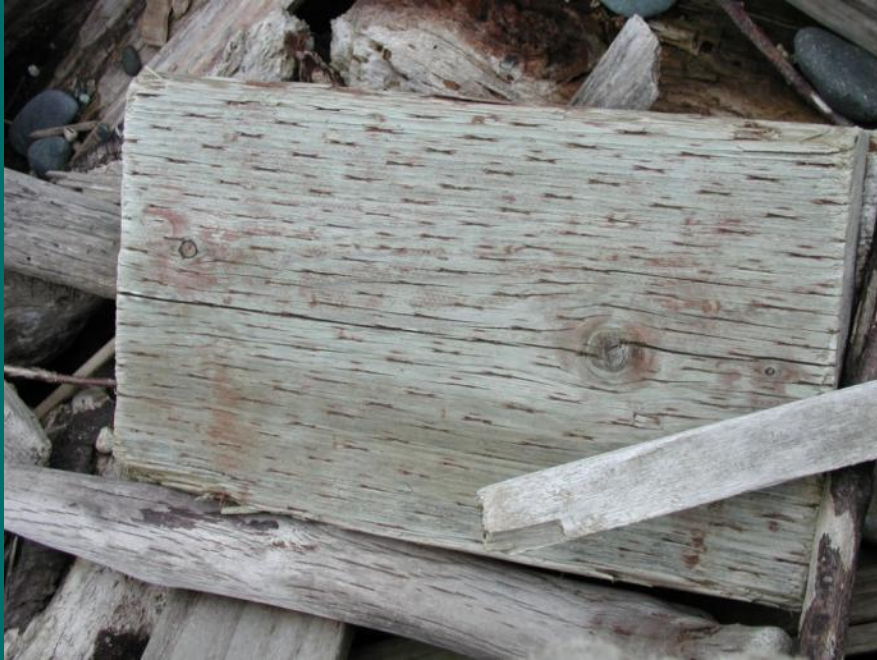
Other Treated Wood

- ACZA = Ammoniacal copper zinc arsenate
- CCA Type C = Chromated copper arsenate
- No longer available for sale
- Newest type on the market = ACQ

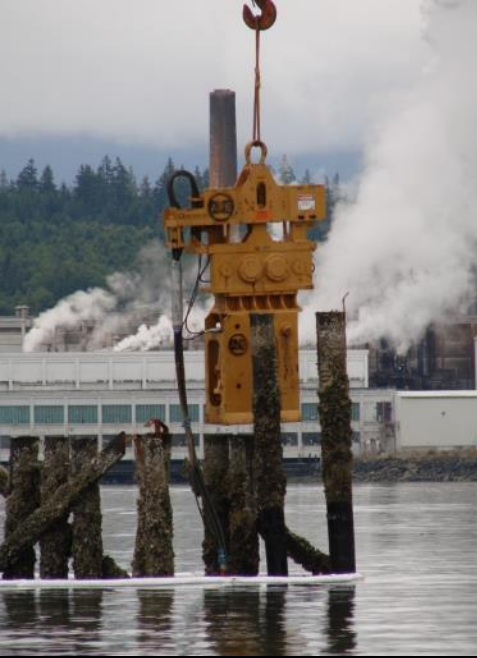
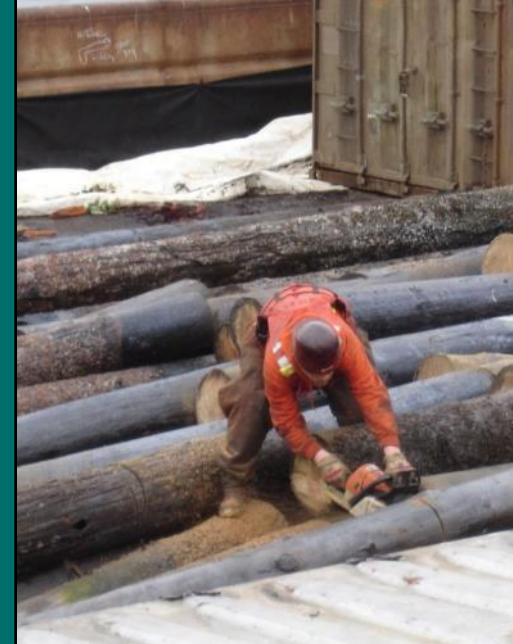
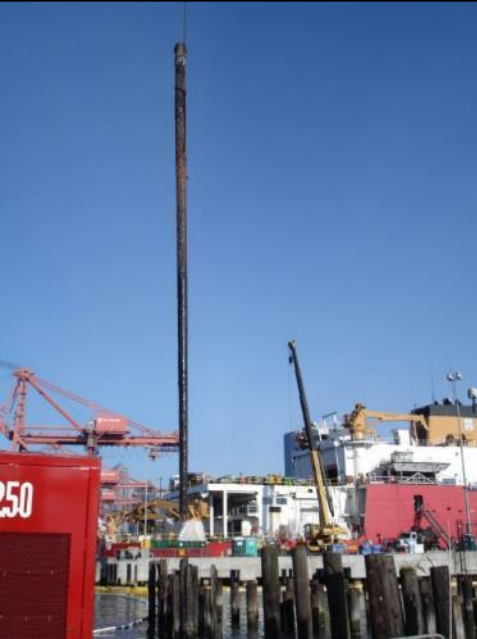
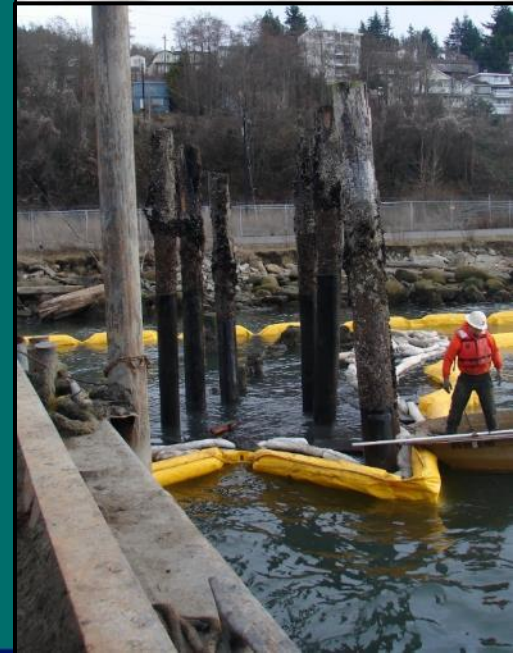
- Vibratory hammer preferred method
- Piles are cut on barge or on land as needed
- Transfer into containers
- Work area is boomed to capture debris and creosote
- Divers may be used to cut piles too deteriorated to pull
