# ISLAND COUNTY MARINE RESOURCES COMMITTEE

# May 7, 2024

# ISLAND COUNTY SHORELINE ARMOR MAPPING & CHANGE ANALYSIS

TEAMS PRESENTATION | MAY 7, 2024

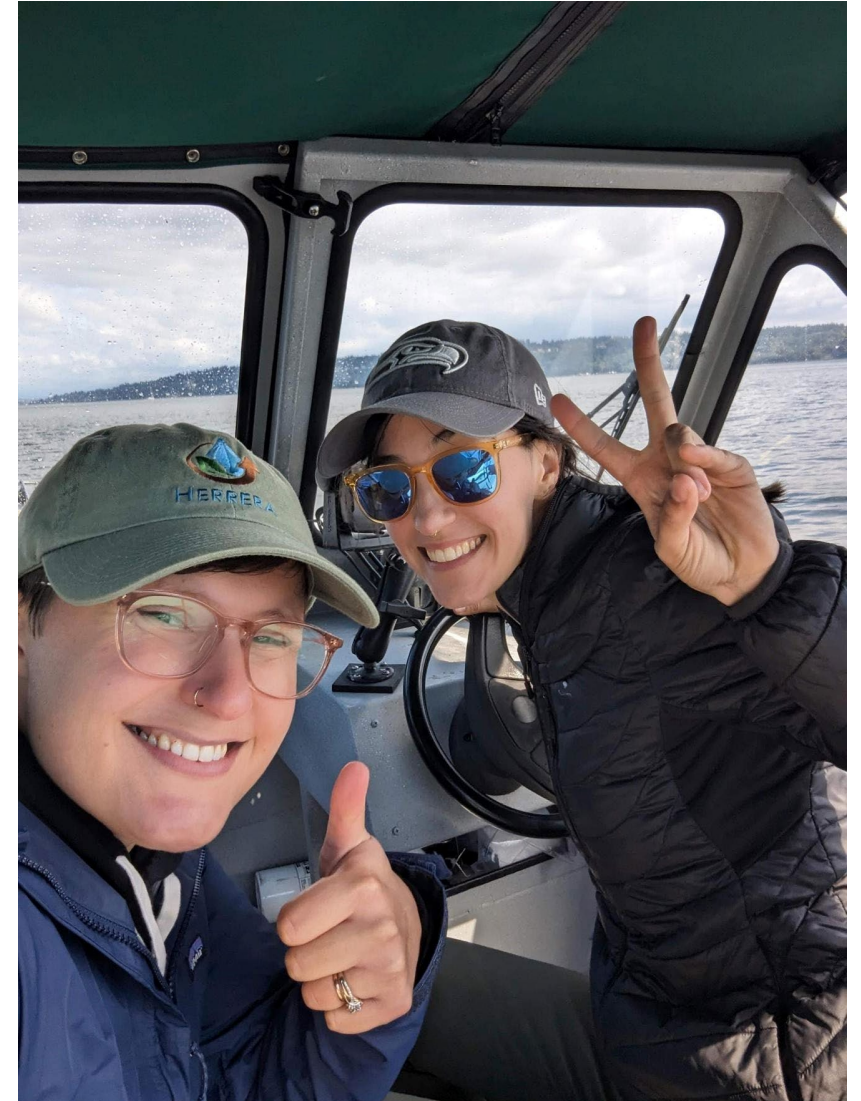
# SHORELINE ARMOR MAPPING METHODS

- Boat-based mapping
  - GNSS GPS + Laser Rangefinder
  - Digital Field Form
  - High-tide cycle for shallow areas

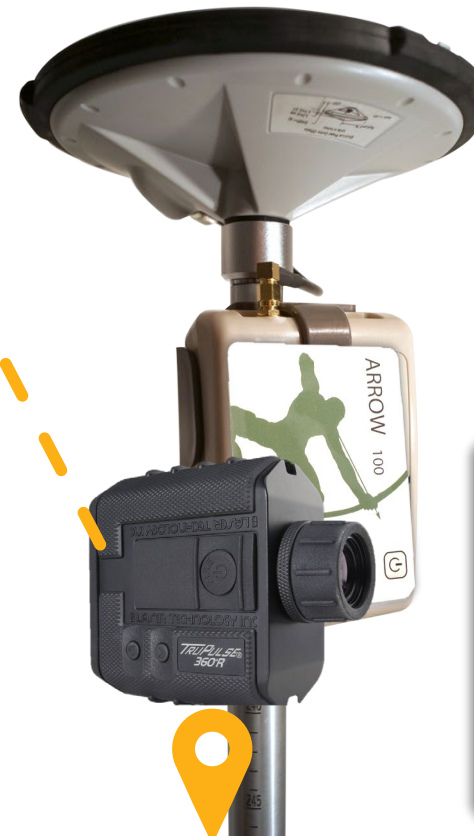
# LASER OFFSET MAPPING

## ■ How it works:

- Collect a GPS point
- Within digital field form, “offset” the GPS point
- Fire the laser rangefinder at the mapping target
- The GPS point is shifted in FieldMaps to the target location

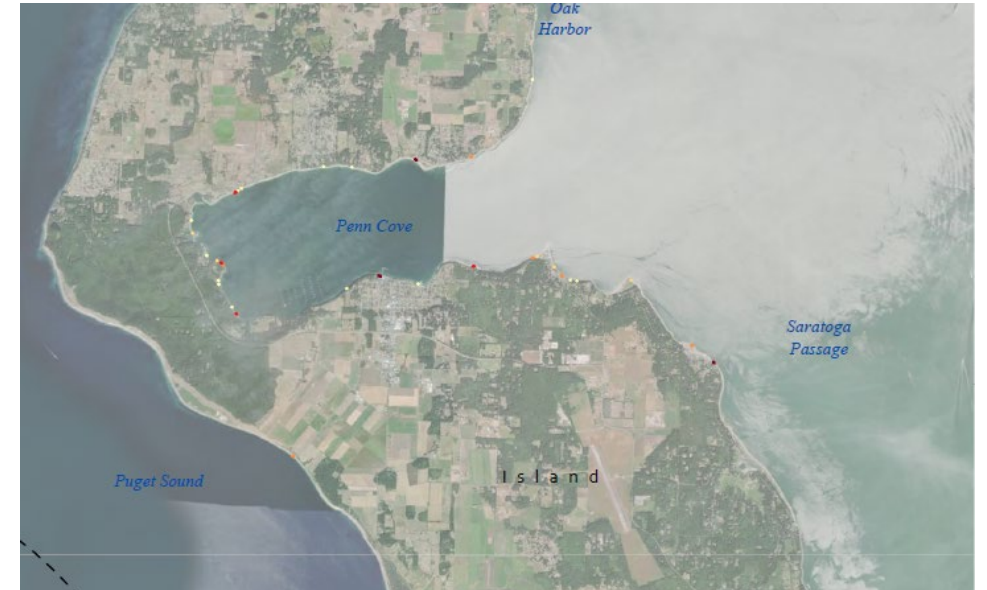
# SHORELINE ARMOR CHANGE RESULTS

- Island County armor change (2016 to 2023):
  - 391 new armor segments
  - Mappers observed active shore armor construction at 4 locations
  - 64% of new armor installed adjacent to existing armor

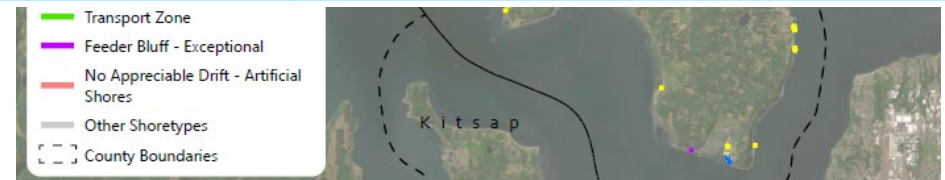
**Table 12. Summary of Geomorphic Shoretype Co-Location with Mapped Shoreline Armor Present in Only 2023, Not in 2016 (Potential New Shore Armor) and Issued Permits<sup>a</sup>.**

- Accretion shoreforms and feeder bluff most frequently armored
  - 59% of new armor on accretion shoreforms
  - 20% of new armor on feeder bluffs

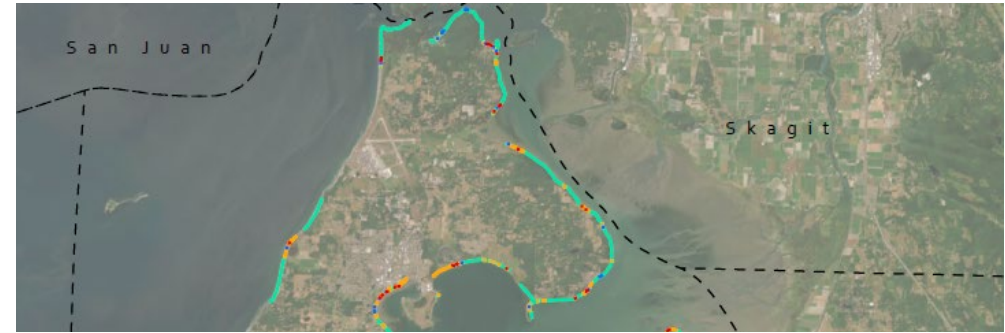
- 30% of forage fish spawning habitat was armored in 2023
  - 29% of habitat armored in both 2016 and 2023
  - New armor on 1.3% of habitat
  - Armor removed from 1% of forage fish spawning habitat

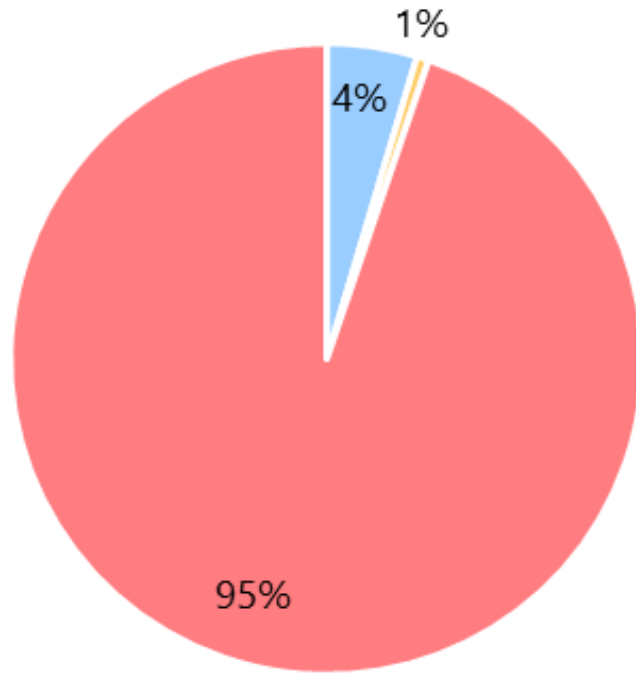
New Armor + Permit Associations  
(Count of Parcels)

- New armor + approved armor permit
- New armor + denied permit
- New armor + no permit

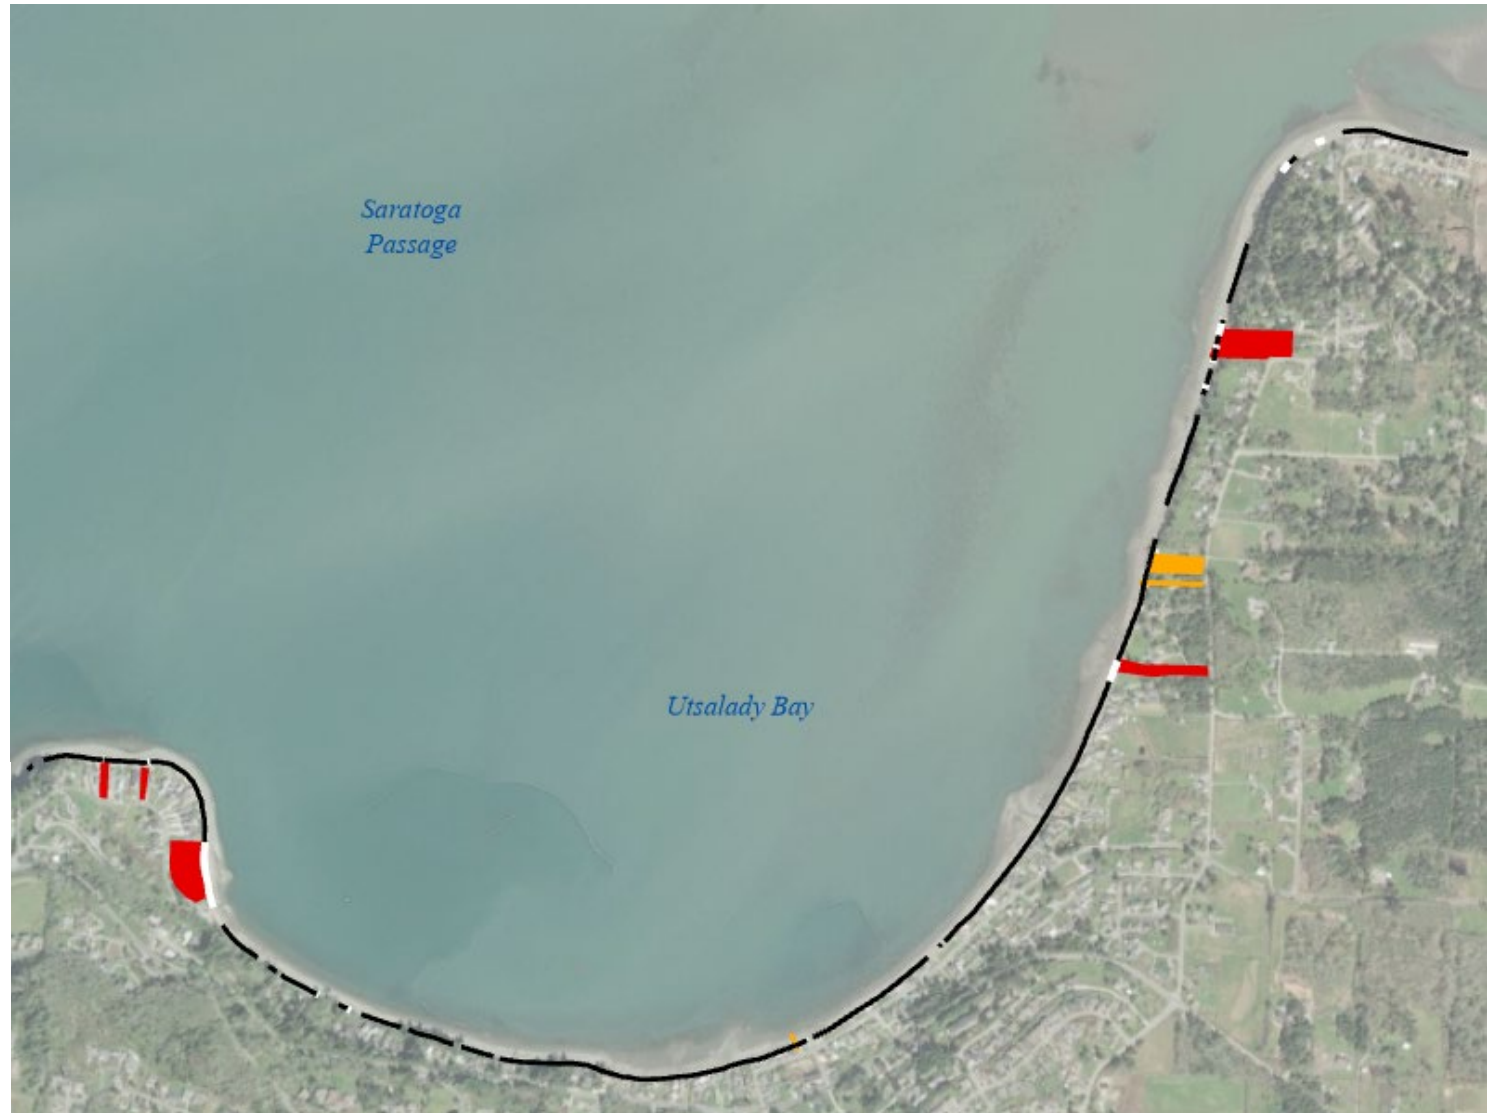
- Widespread permitted and unpermitted change
  - Most change clustered in existing developments
  - Some parcels had more than one permit
- Example sites:

Mapped change without associated permits

- Potential new shore armor
- Potential shore armor removal
- Potential change in shore armor

Mapped change with associated permits

- Permit issued for new armor
- Permit issued for armor removal
- Permit issued for armor alteration
