NAS Whidbey Island Natural Resources Program

Michael Bianchi NEPA Program Coordinator, NAS
Whidbey Island/NAVFAC NW

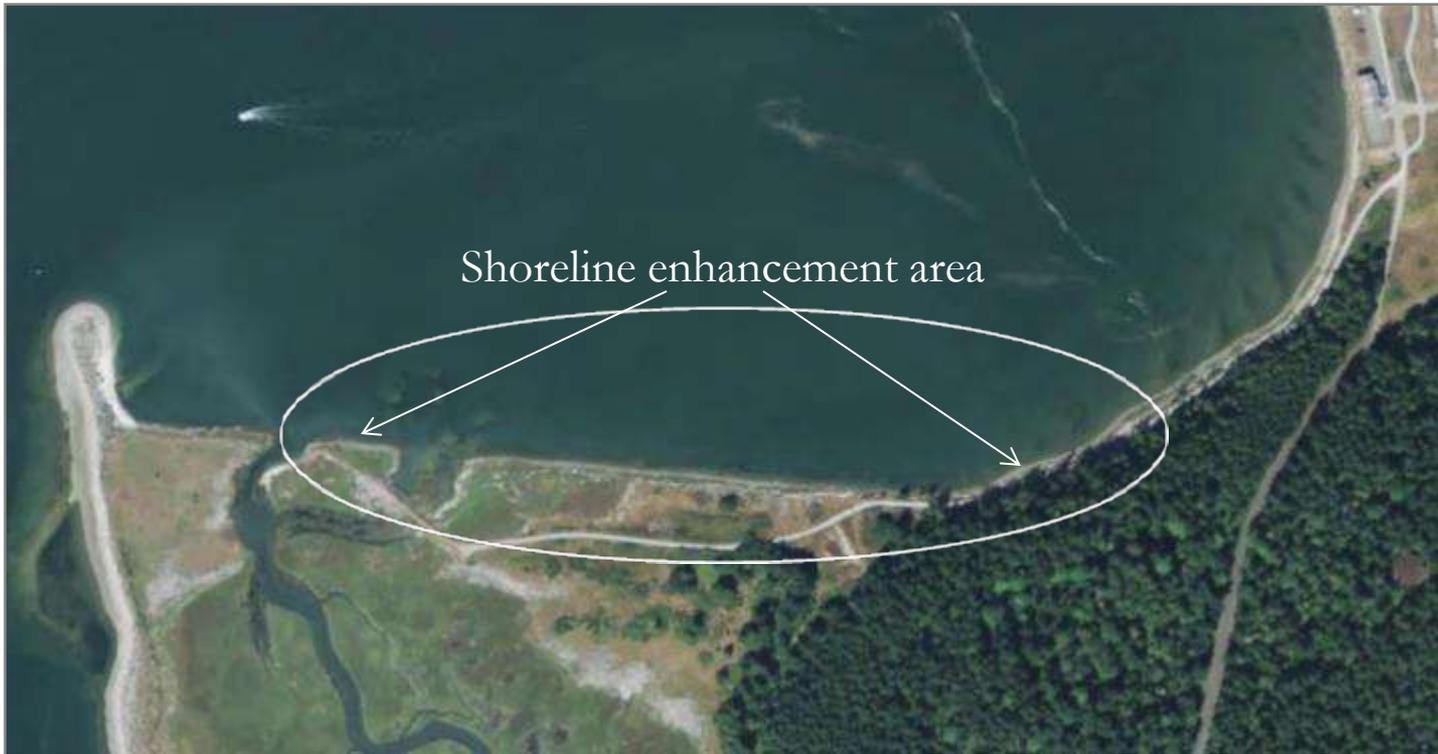
Maylor Beach Restoration Site Location

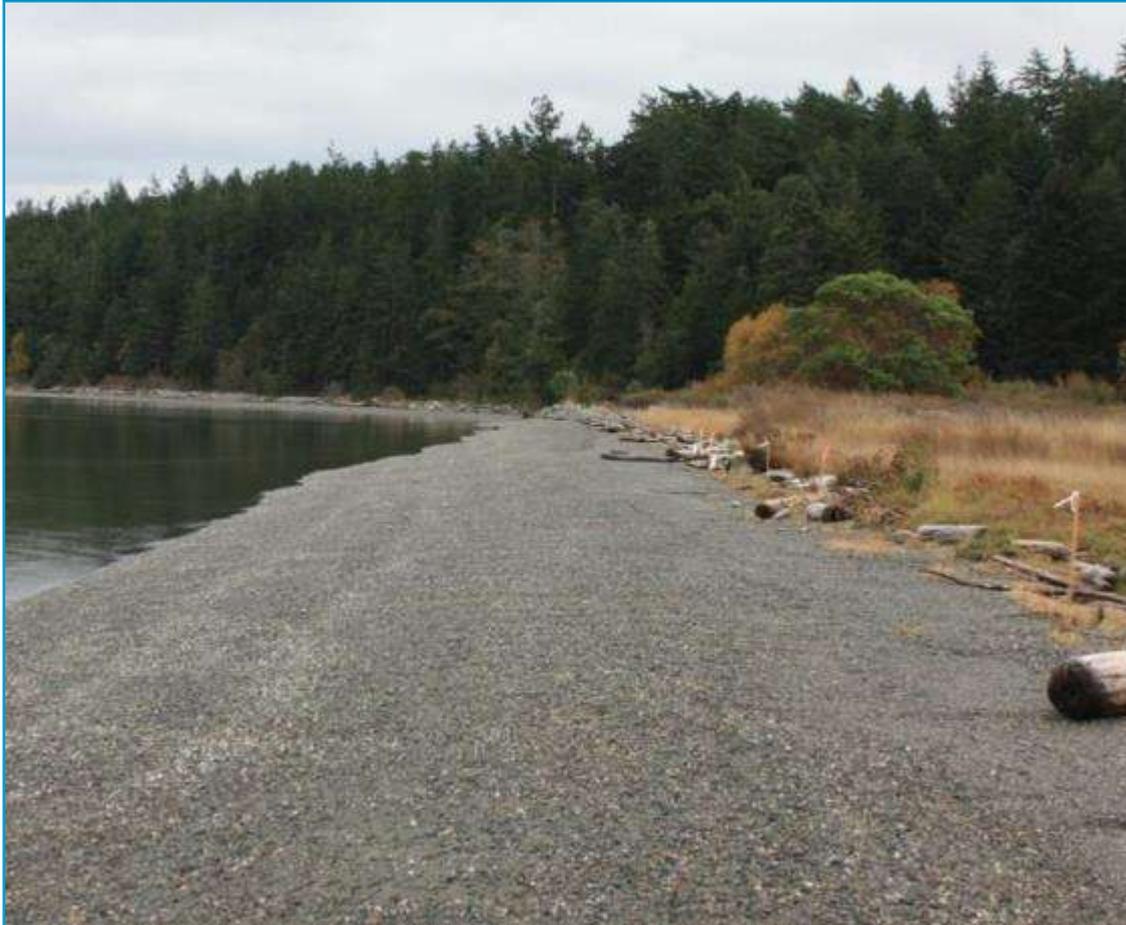
Beach Profile View Looking East

Maylor Beach Restoration Completed Section

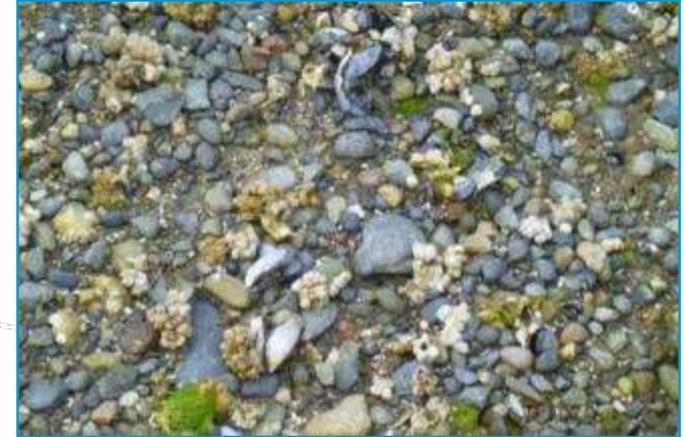
Original Substrate

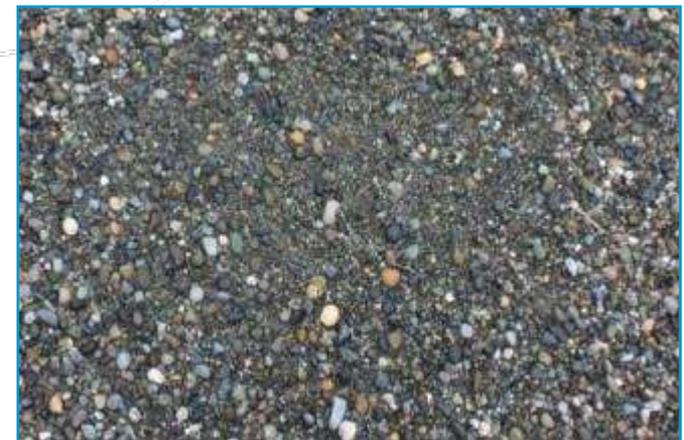
New Fish Mix

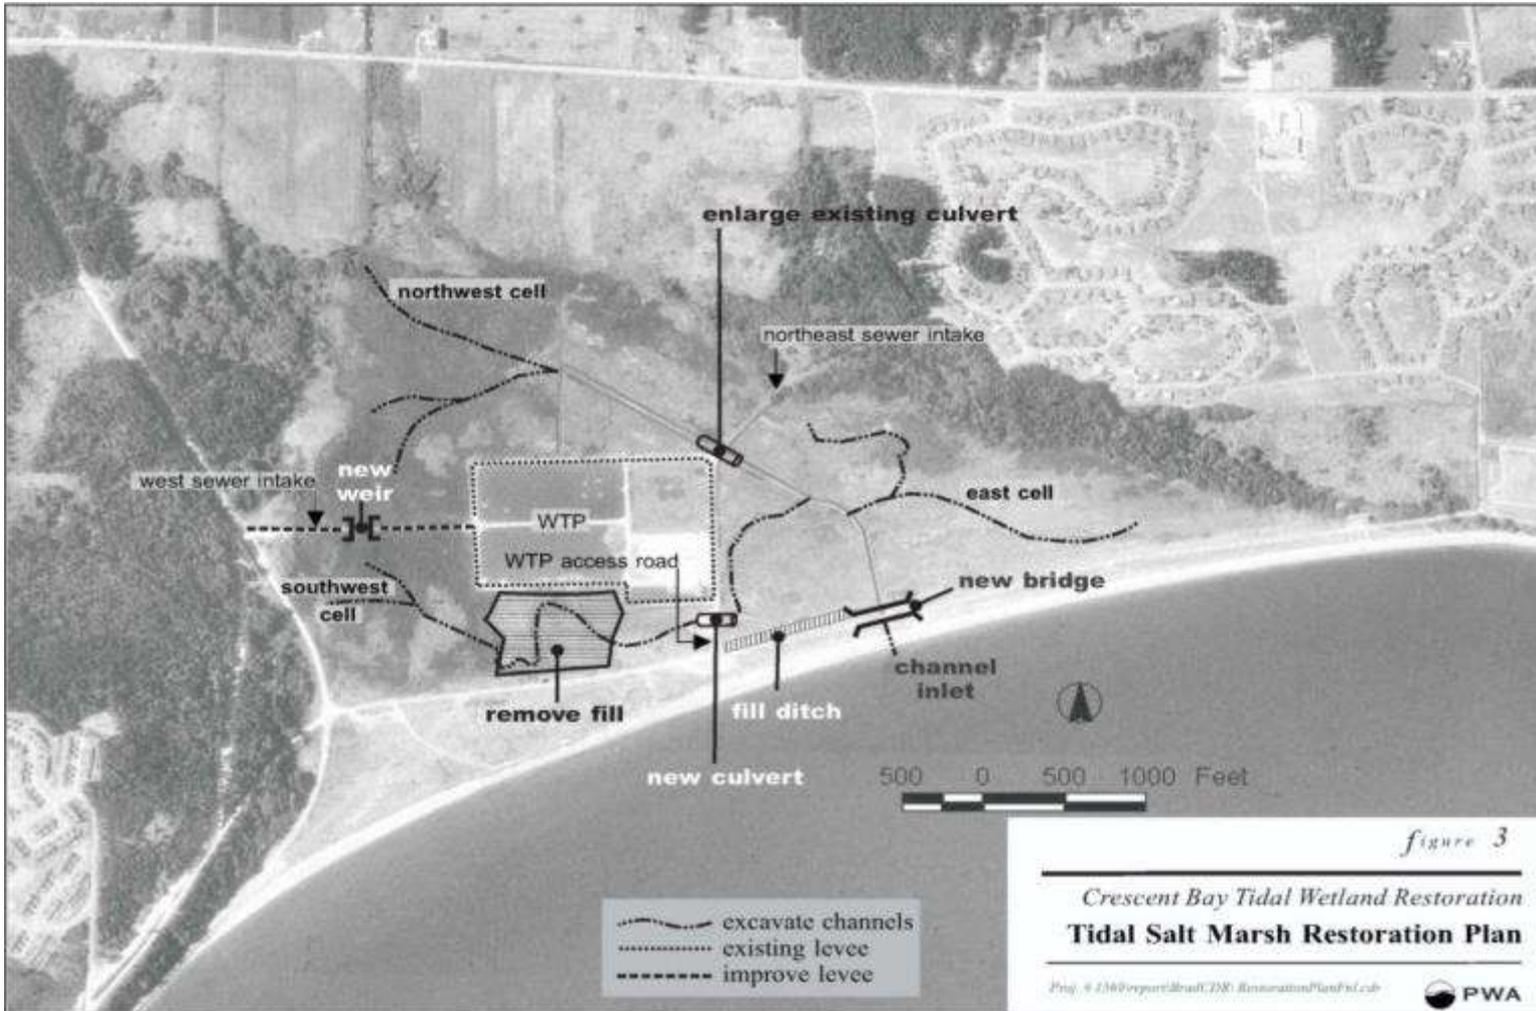
Initial (2003) Restoration Design

- Navy began to restore saltwater marsh and in 1994, tide gate system was permanently winched open to restore a saltwater connection and creating a small saltwater marsh near the tide gate
- The completed 2003 feasibility study, recommended full tidal restoration of the system to benefit Chinook salmon with suitable design so as not jeopardize the wastewater treatment plant or other infrastructure

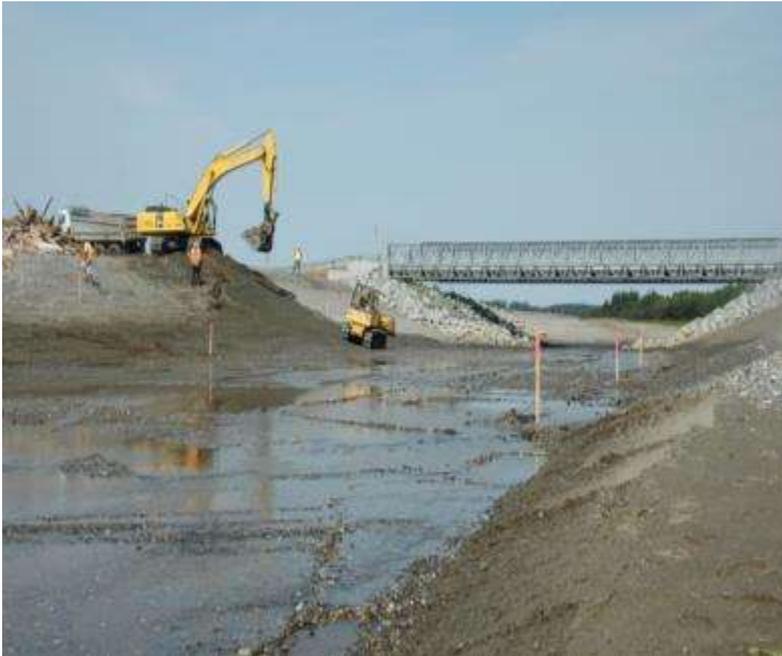
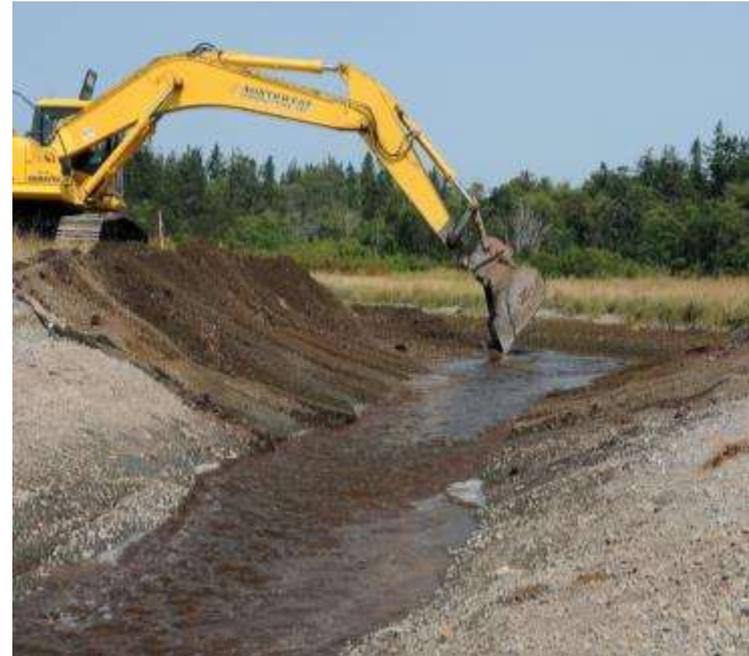
Final excavation of new inlet channel

- Summer 2009, berm cuts, tidal channels and culvert replacements completed and on 19 Aug. 2009, final berm cut made under the East Pioneer Way bridge

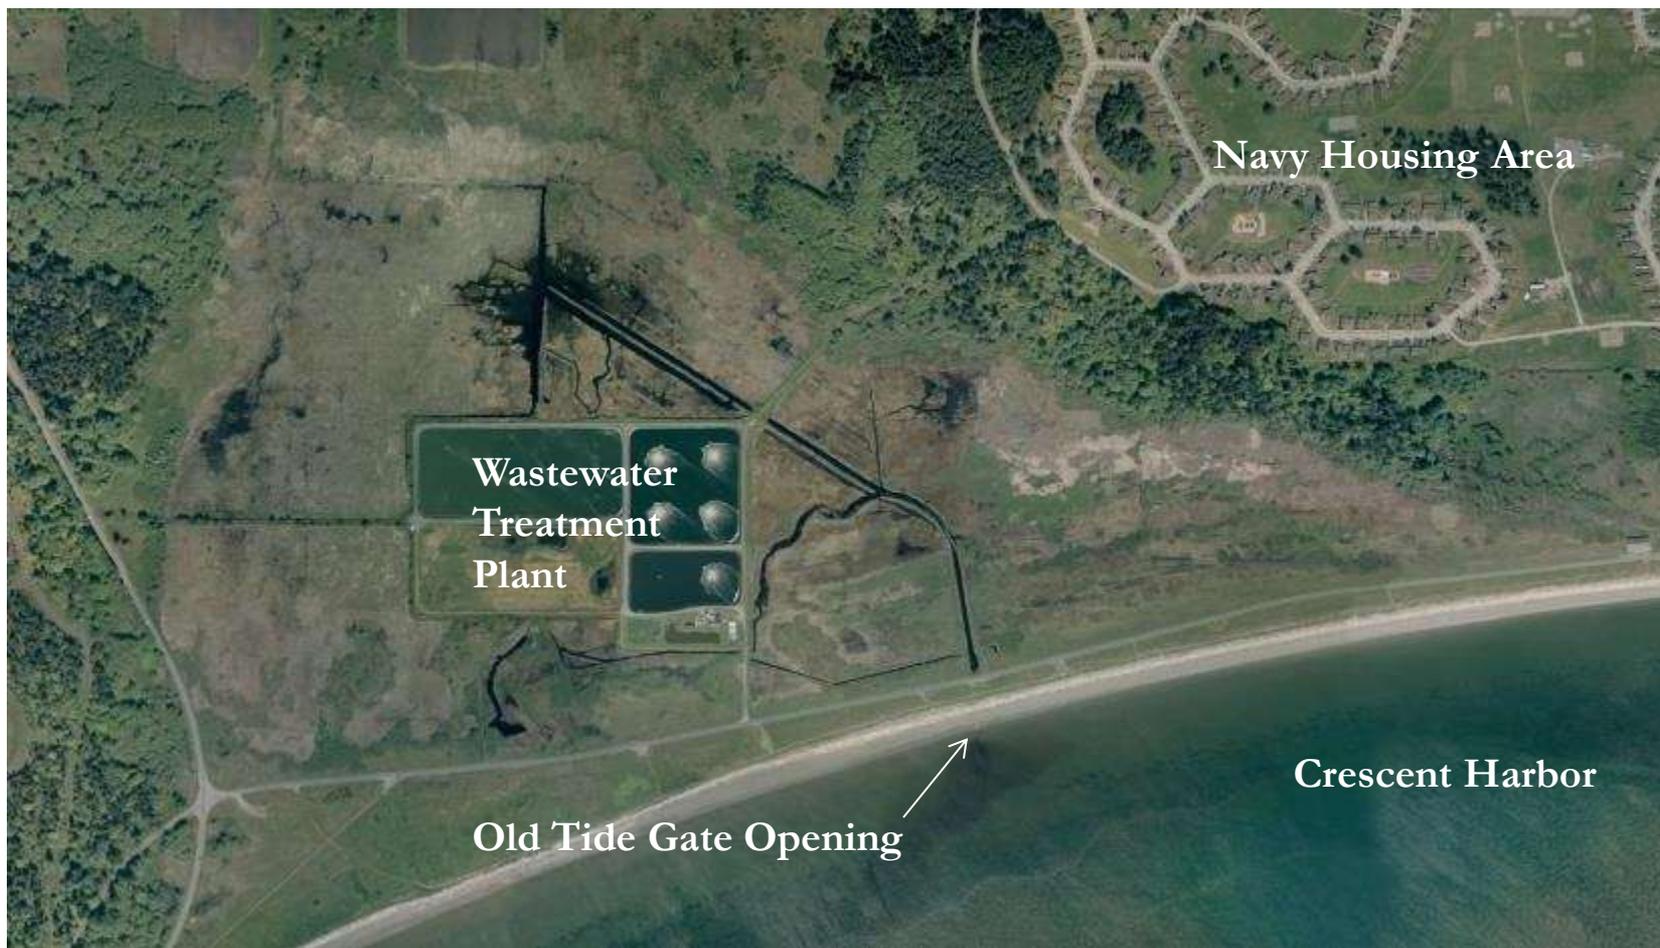
Restoration Site Aerial Photo (June 2003 Before Tidal Inundation)

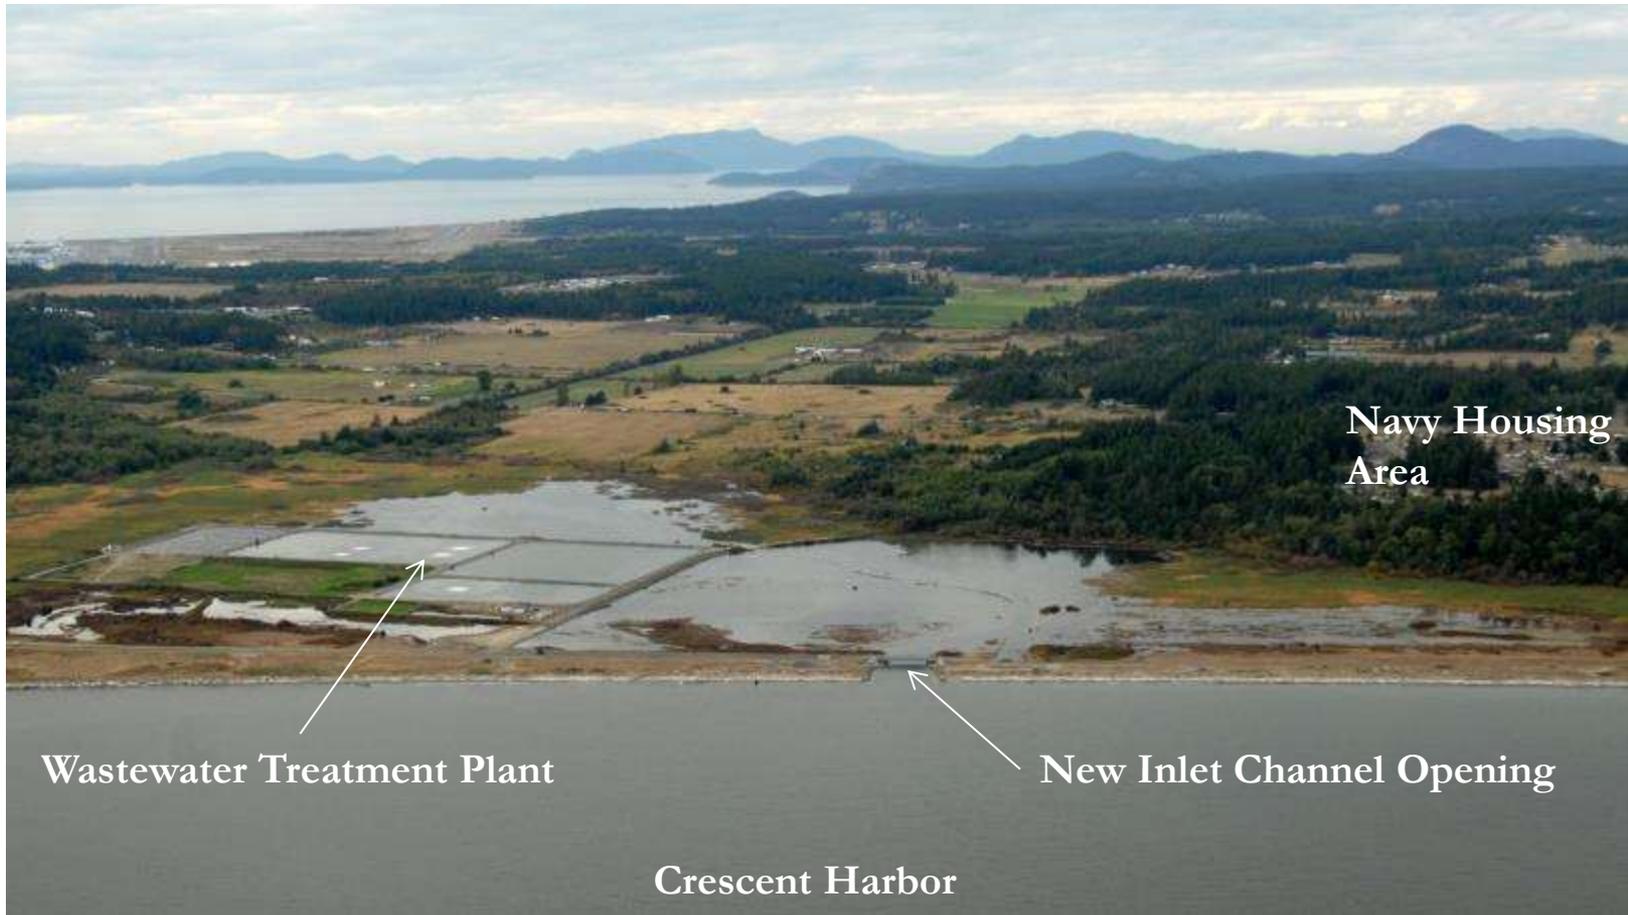
Restoration Site Aerial Photo (2009 After Tidal Inundation)

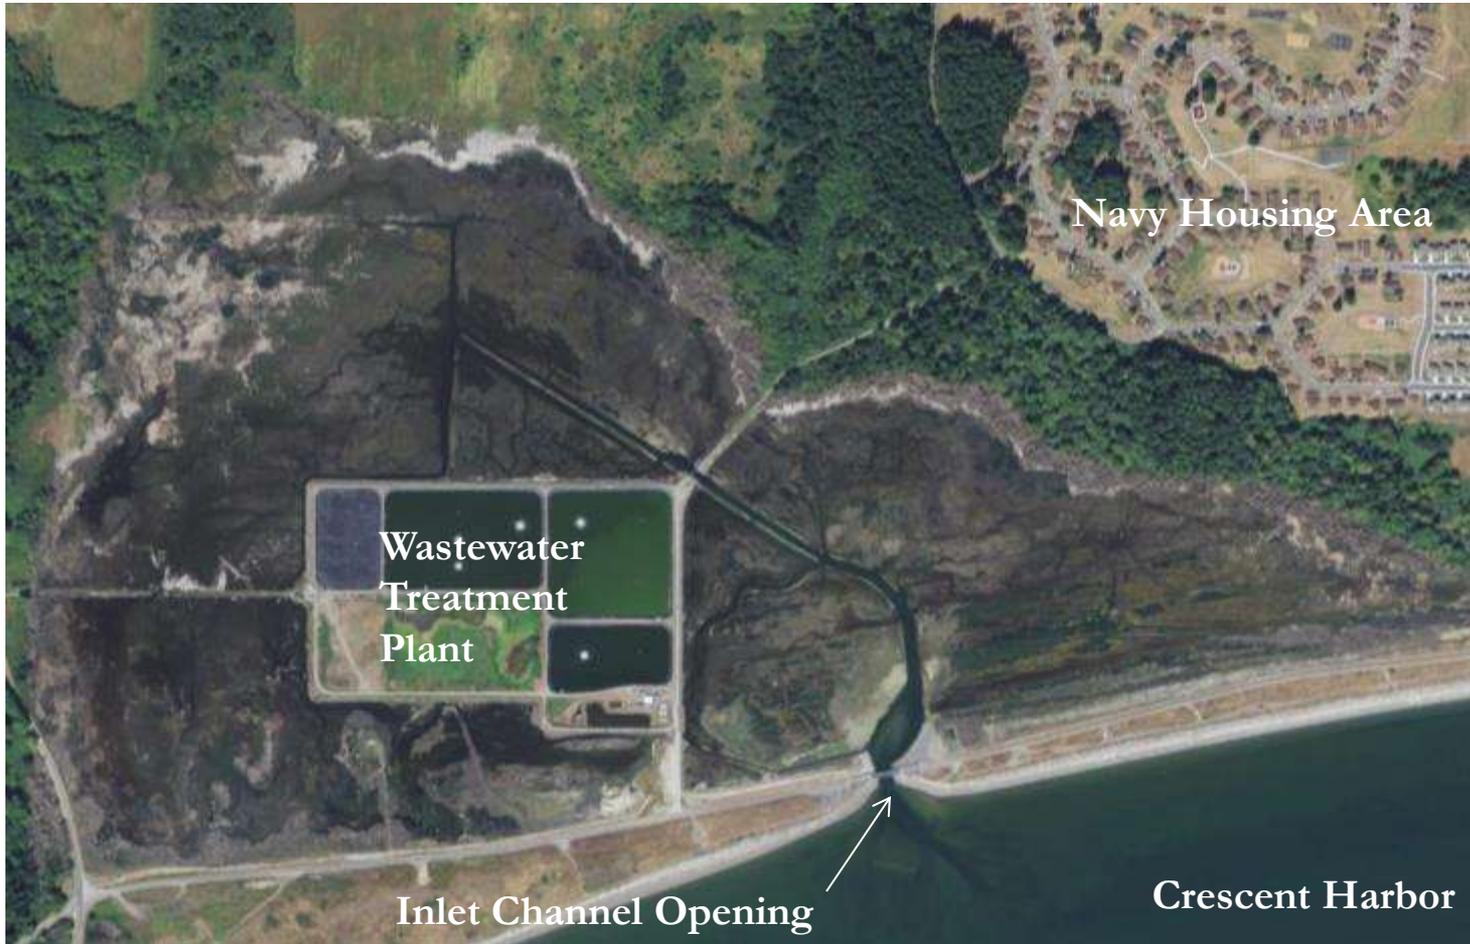
Restoration Site Aerial Photo (2011 After 2-years of Tidal Inundation)

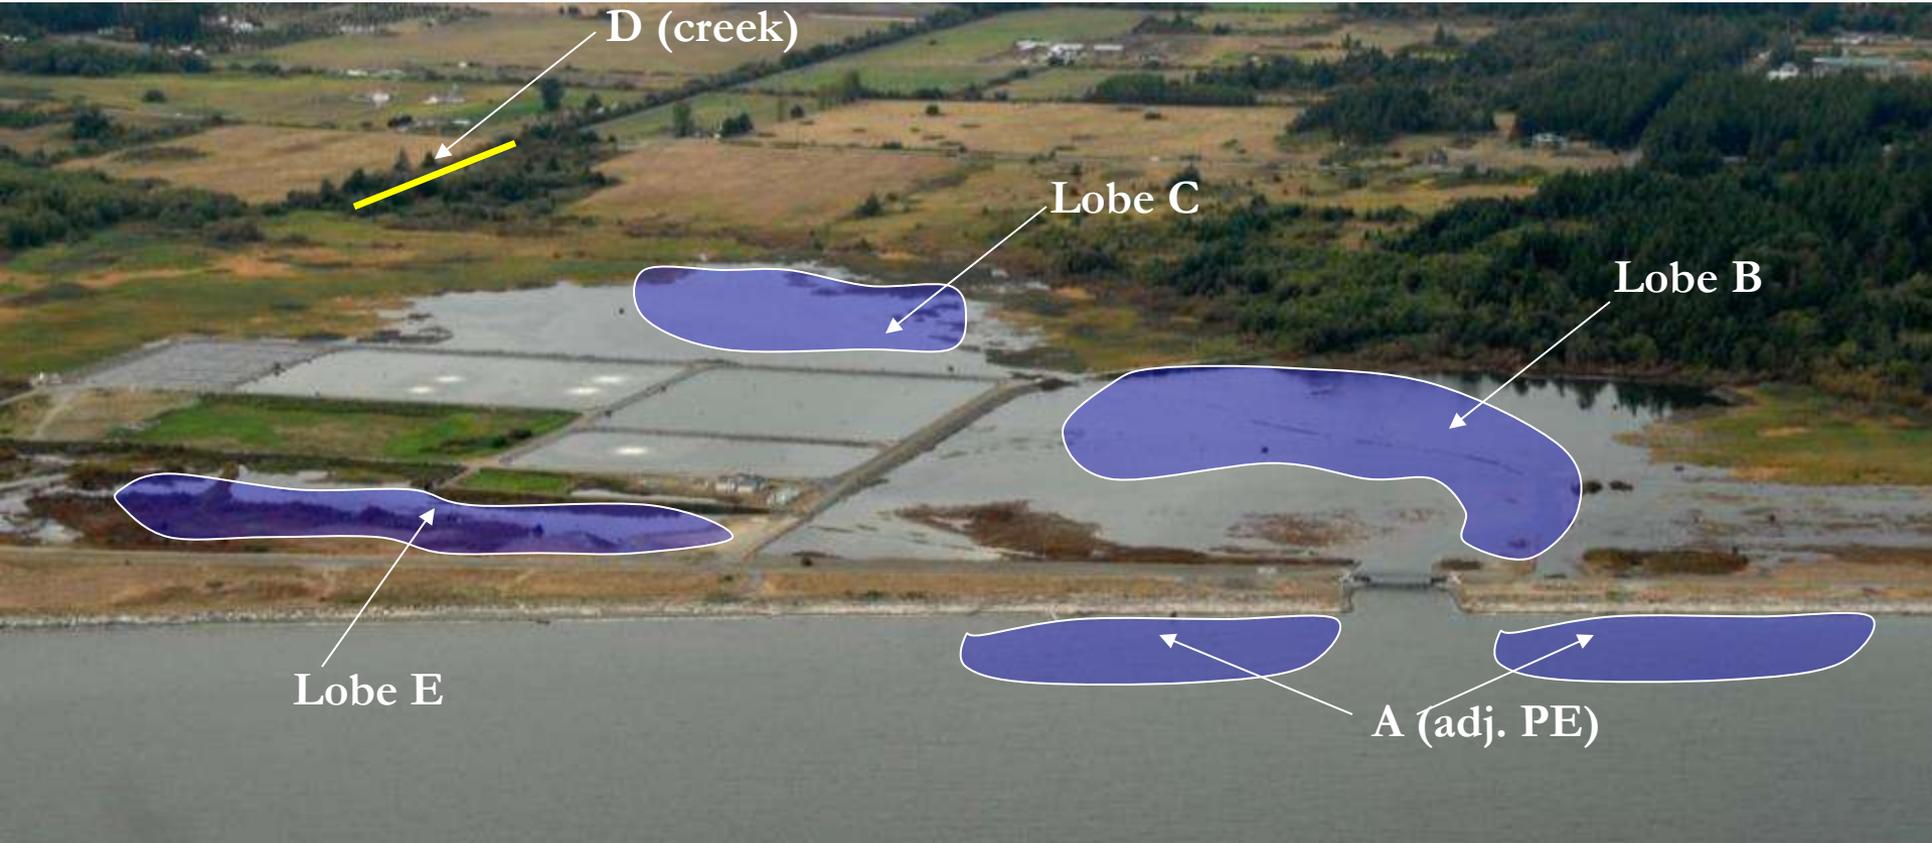
Crescent Harbor Sampling Site Design

- 5 spatial strata, 2 gear types, 4 beach seine sets per strata (except creek – which is electrofished)

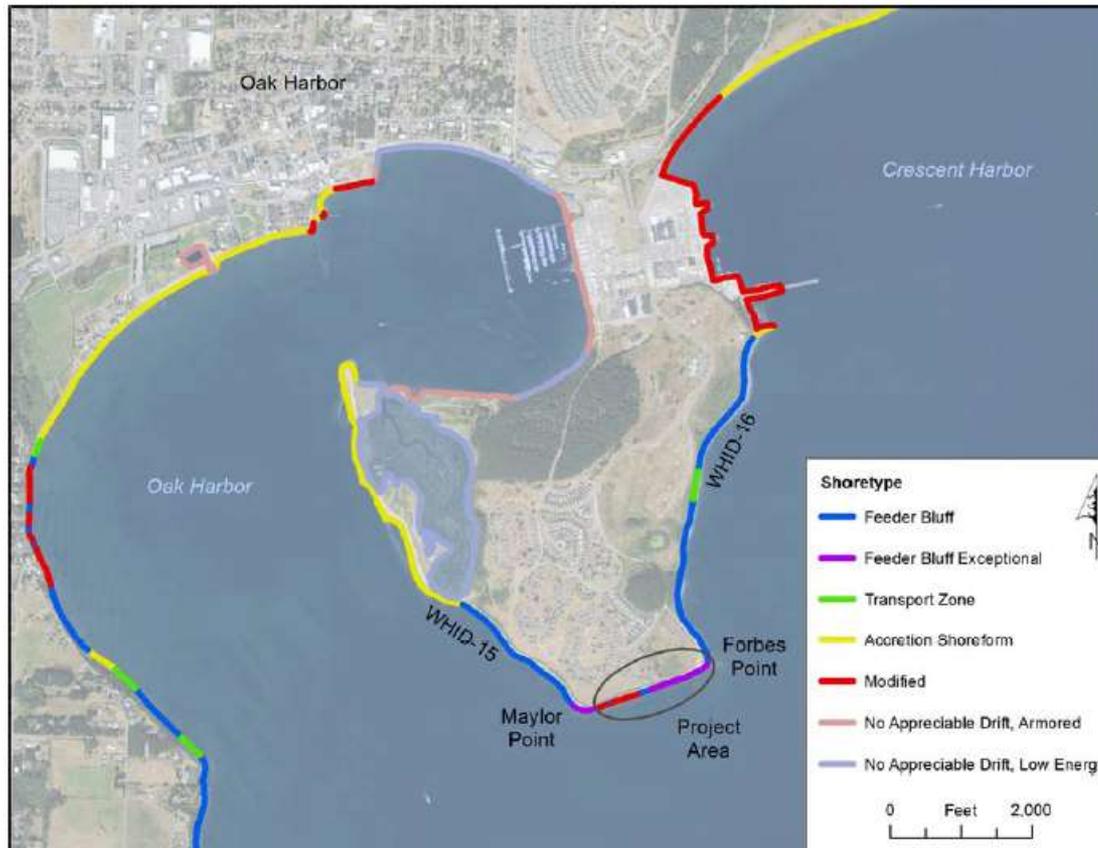
Figure 2. Geomorphic shoretypes of the Maylor Point to Forbes Point area. Note the deteriorated status of some armor resulted in mapping of feeder bluffs where portions of armor remained. (MacLennan et al. 2013)
